INDOOR AIR QUALITY ASSESSMENT

**Middlesex County Courthouse Tower
40 Thorndike Street
Cambridge, Massachusetts**

Prepared by:
Massachusetts Department of Public Health
Bureau of Environmental Health Assessment
Emergency Response/Indoor Air Quality Program
January 2002

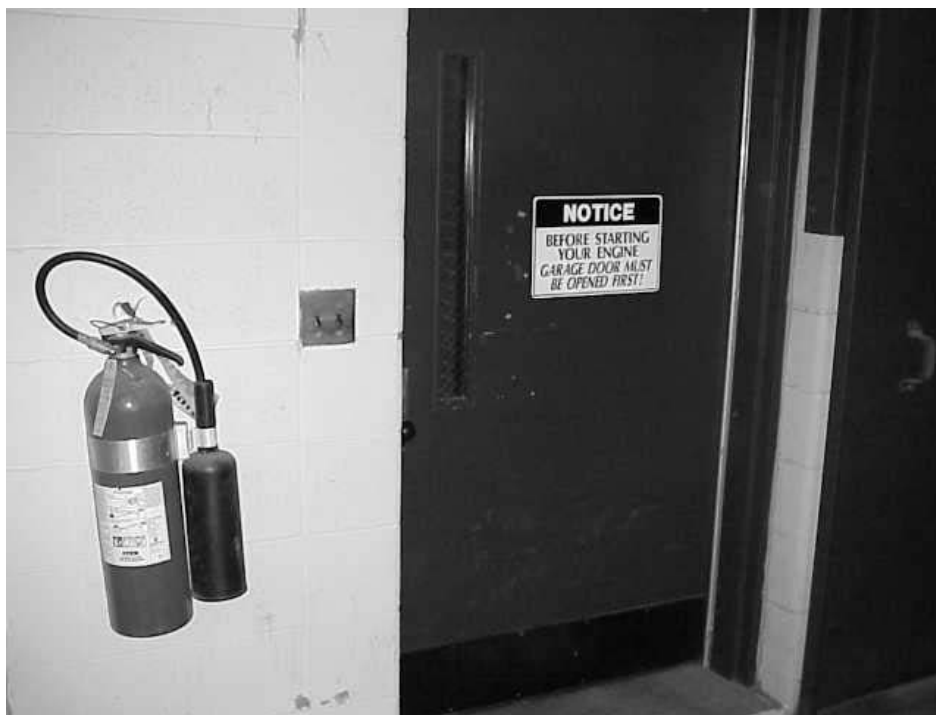
Picture 1

Action Taken: With the exception of the loading dock door opposite the elevators on the basement level, BEHA staff found all doorways to these areas closed. Each of these doors was posted with a sign instructing occupants to keep door closed (see Picture 1).

Stairwell Door Leading To First Floor Parking Lot, Note Posted Sign

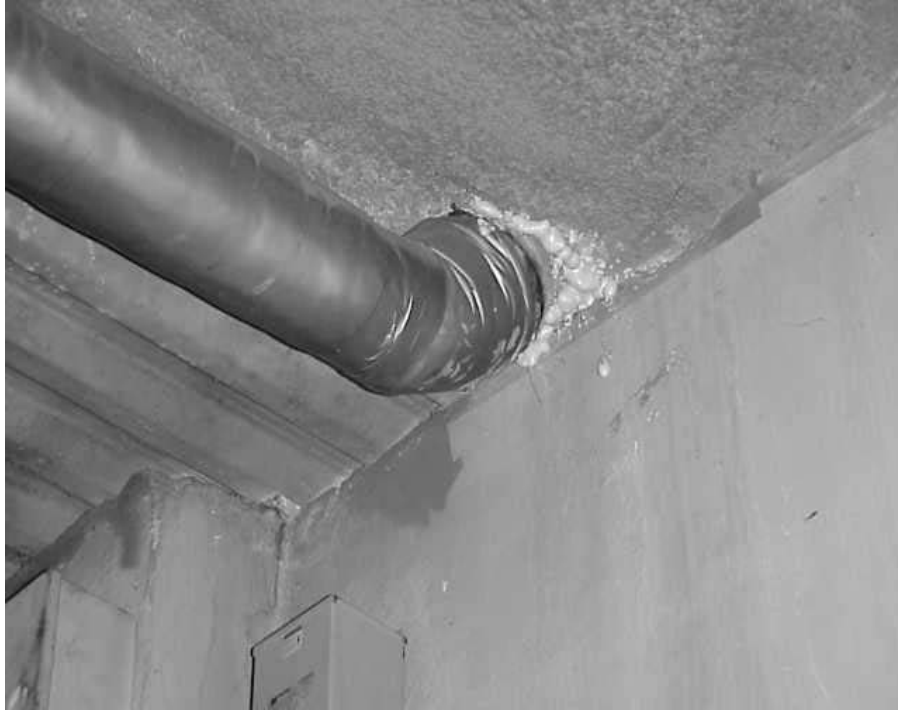
Picture 2

Action Taken: Utility holes in indoor garages were sealed with a spray caulking material (see Picture 2). In order to assess whether containment measures were effective to prevent pollutant movement from the first floor parking garage into occupied areas of the MCCT, air monitoring for carbon monoxide and ultrafine particles was conducted around each interior door as well as within the parking garage while vehicles were leaving. The combustion of gasoline can produce carbon monoxide and particulate matter that is of a small diameter [10 microns (μ)] and can penetrate into the lungs to cause irritation. For this reason a device that can measure 10 μ or less particles was used to identify pollutant pathways from the parking garage into occupied areas. No detectable levels of carbon monoxide were measured around hallway doors adjacent to the parking garage. However, ultrafine particles (over background levels taken in the stairwell of the central staircase) were noted emanating through seams and holes around the parking lot doors (see Picture 3). The presence of these particles doesn't suggest health risks but does indicate

Sealed Pipe/Ceiling Junction with Spray Foam Sealant

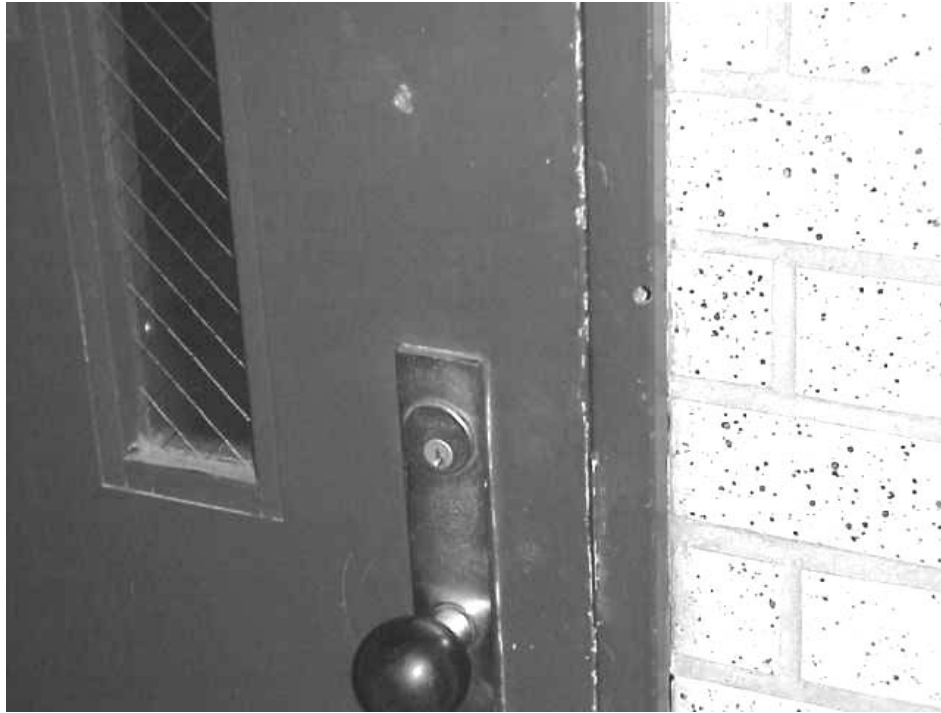
Picture 3

Hole In Parking Garage Doorframe Serving as Air Pathway

Based on these observations, all seams along doorframes and electrical outlets around parking garages should be rendered airtight to reduce pollutant penetration. Sealing of wall areas may provide a barrier to reduce pollutant migration from indoor parking lots. The addition of local exhaust ventilation for the indoor parking garages would serve to remove vehicle exhaust directly from the building. It is highly recommended that the feasibility of installing mechanical exhaust ventilation be determined for each indoor parking area and loading docks by a ventilation engineer.

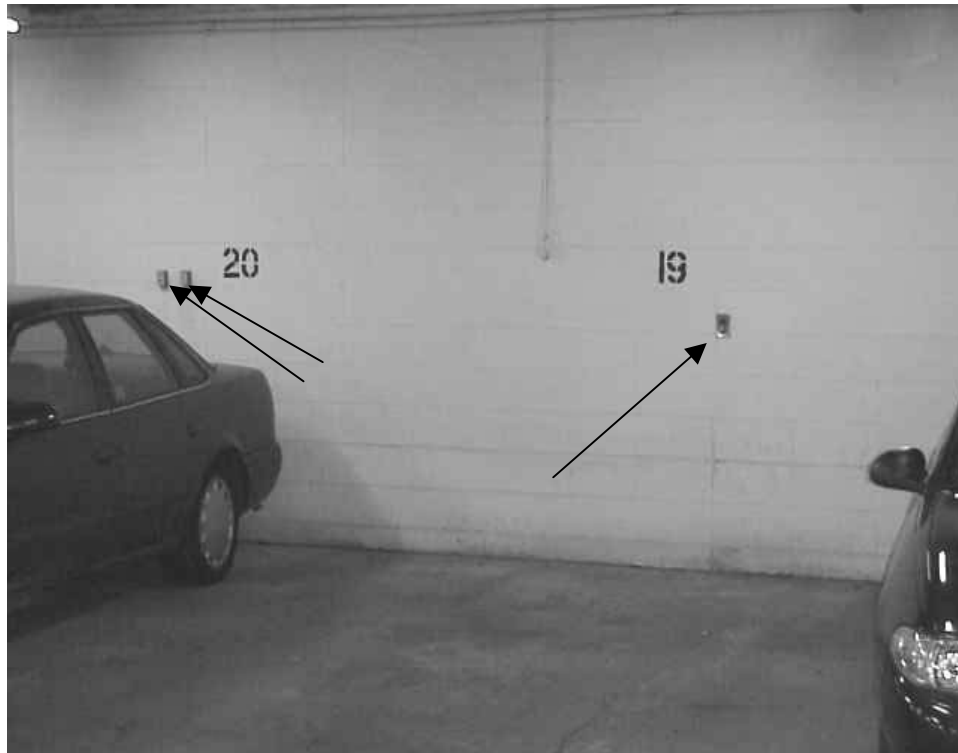
Picture 4

Wall Electrical Outlets and Thermostats in Parking Garages.

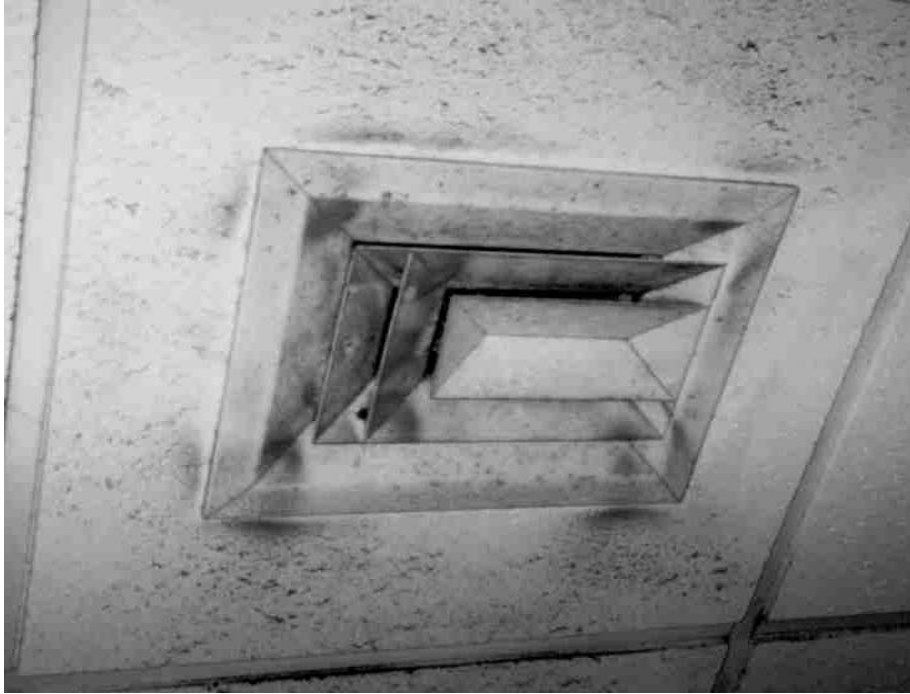
Picture 5

Dust deposition around ceiling fresh air diffusers (see Picture 5) was observed in a number of areas. Soot from vehicle exhaust related to indoor parking garages was initially identified as a possible source of this deposition (MDPH, 1998). Several conditions indicated that filtered outside air may also be a contributing source of the deposition. A survey of fresh air intake conditions was conducted on floors 7 through 14 (see Table 26). Filters had spaces between/around the frame and the installation rack, which can allow unfiltered air to penetrate into the air-handling unit (AHU) (see Pictures 6 through 8). Access doors to some AHUs were blocked with pipe installations, making filter change impossible (see Picture 9). On these floors, filters may be missing or saturated with other debris. Both of these conditions can allow

Example of Heavy Particle Deposition around Fresh Air Supply Vent Prior To Cleaning Efforts by MCCT Staff

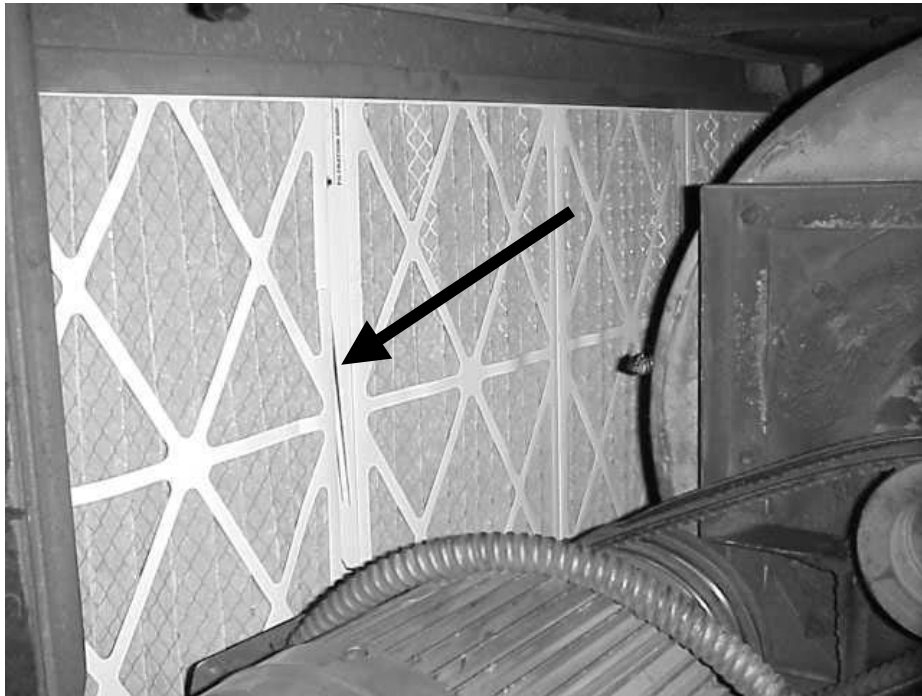
Picture 6

Spaces Between Filters in AHU

3. Torn and/or damaged fiberglass insulation on AHUs should be repaired or replaced.
4. All AHUs should be installed with adequate air filters that are routinely replaced consistent with manufacturer's recommendation.

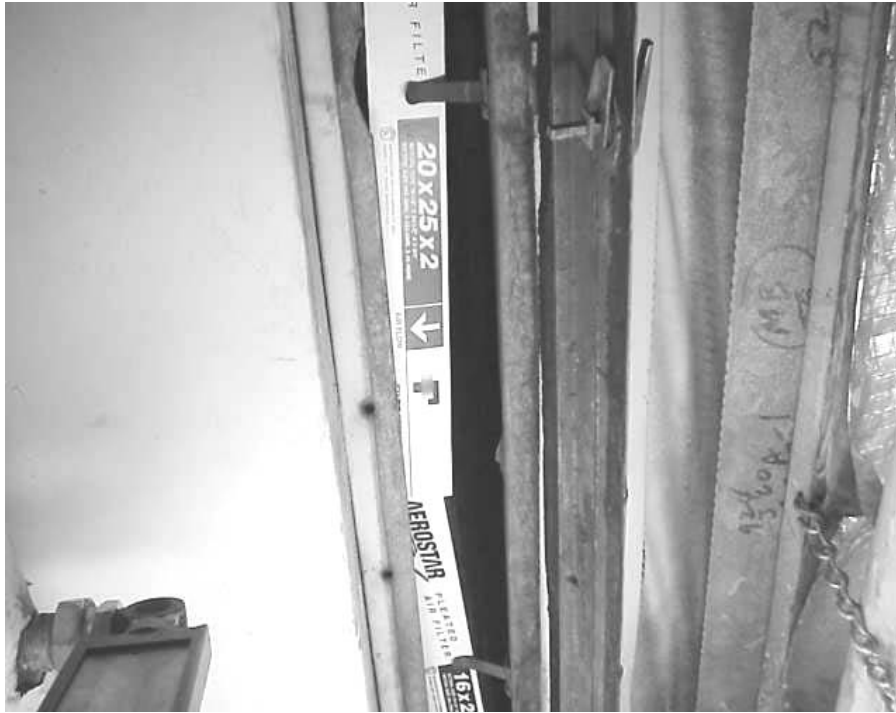
Picture 7

Spaces Between Filters in AHU

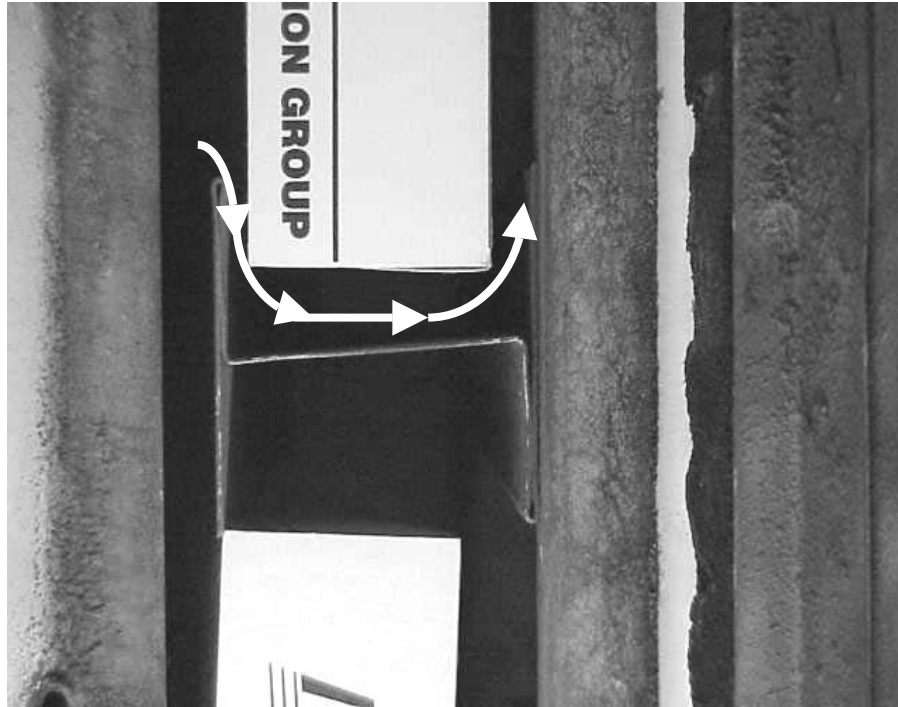
Picture 8

Spaces Between Installed Filters, Arrows Denote Airflow Bypass Path of Filters

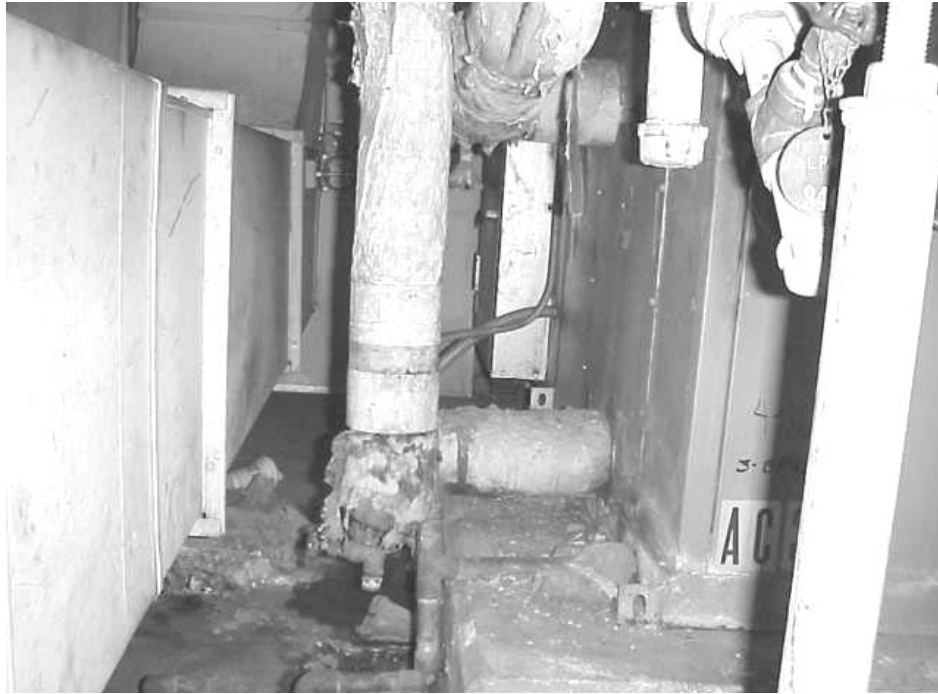
Picture 9

Access To This AHU Blocked by Pipe Installation

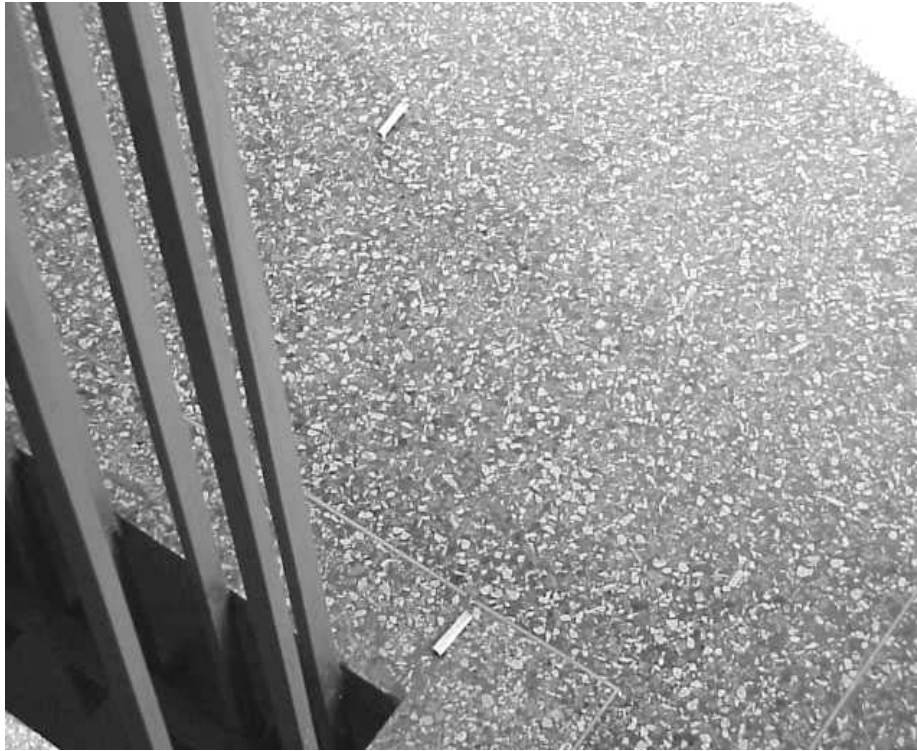
Picture 10

Action Taken: A memorandum instructing the discontinuance of smoking was circulated to the MCCT staff. Cigarette butts were noted in a number of areas on nearly all visits to the building. The most frequent location of cigarette butts was the central stairwell that leads to the MCSO.

Another building wide problem that was evident during all visits to the MCCT is smoking within the building (see Picture 10). Although smoking is banned in this state office building by local city ordinance (Middlesex Superintendent, 1989) and state law (Middlesex Superintendent, 1996), signs of cigarette smoking were observed in several areas, particularly in the central stairwell that leads to the MCSO. Tobacco smoke odors and cigarette butts in a coffee cup were also noted by BEHA staff on the sixth floor in the vicinity of the 6-9 storeroom.

Cigarette Butts On Floor of Central Stairwell

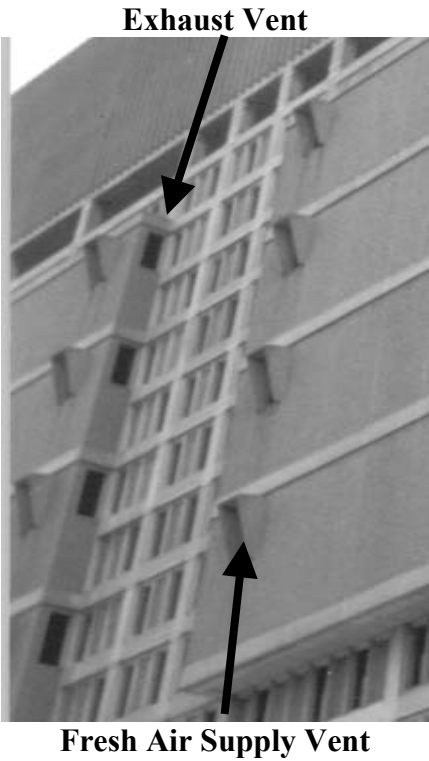
Picture 11

Fresh Air Intakes and Exhaust Vents for Floors 7 through 15

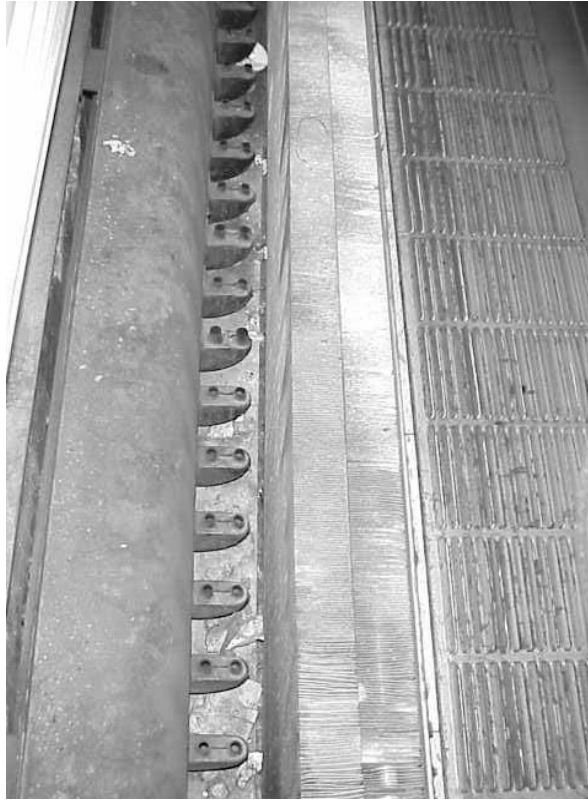
Picture 12

Induction Unit Located Beneath Window of Private Office

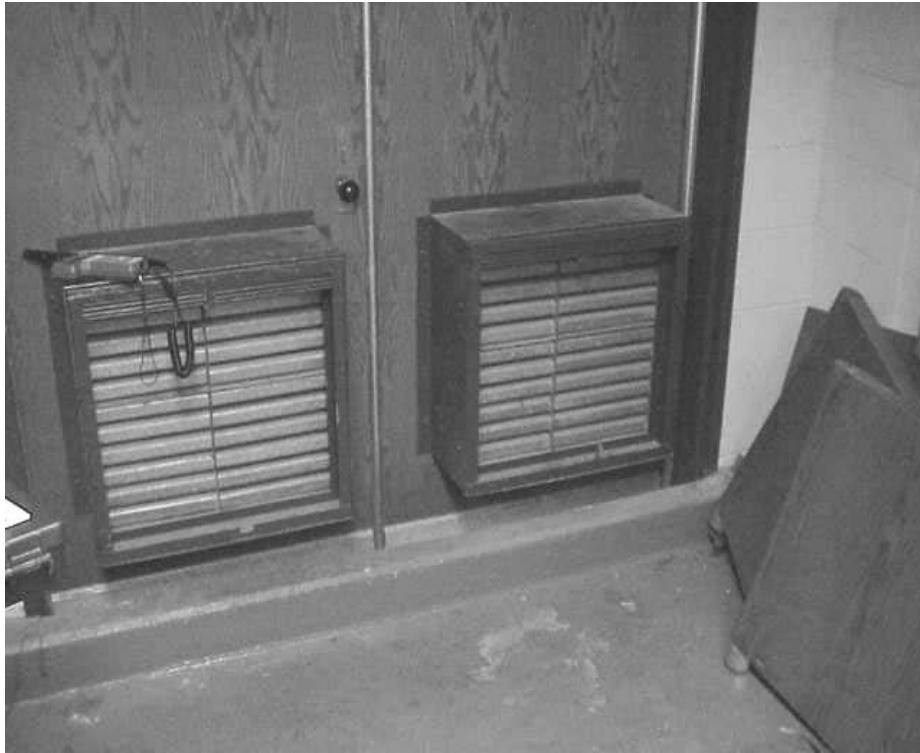
Picture 13

Passive Door Vent Located In AHU Room Door

6. Implement recommendations in previous BEHA correspondence.
7. Restore airflow through AHU passive vent doors to increase exhaust ventilation in hallways.

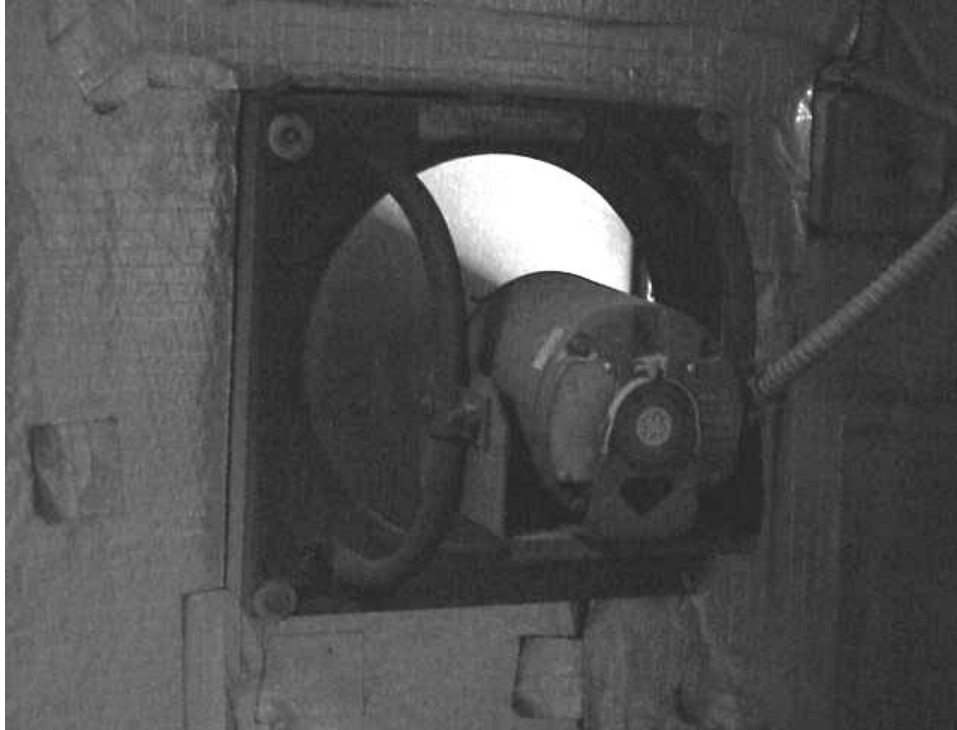
Picture 14

Operating AHU Room Exhaust Fan In General Exhaust System Duct

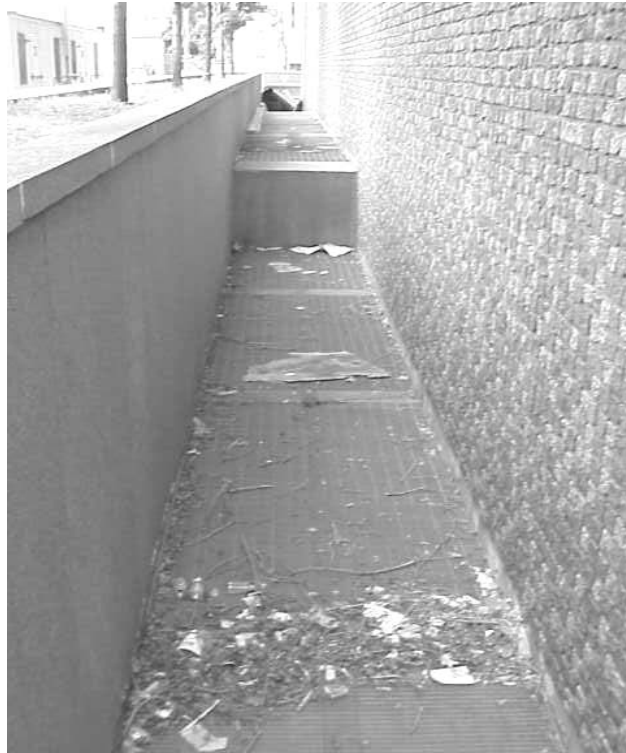
Picture 15

Fresh Air Intakes for the Low-Rise Section in the East Wall of the MCCT

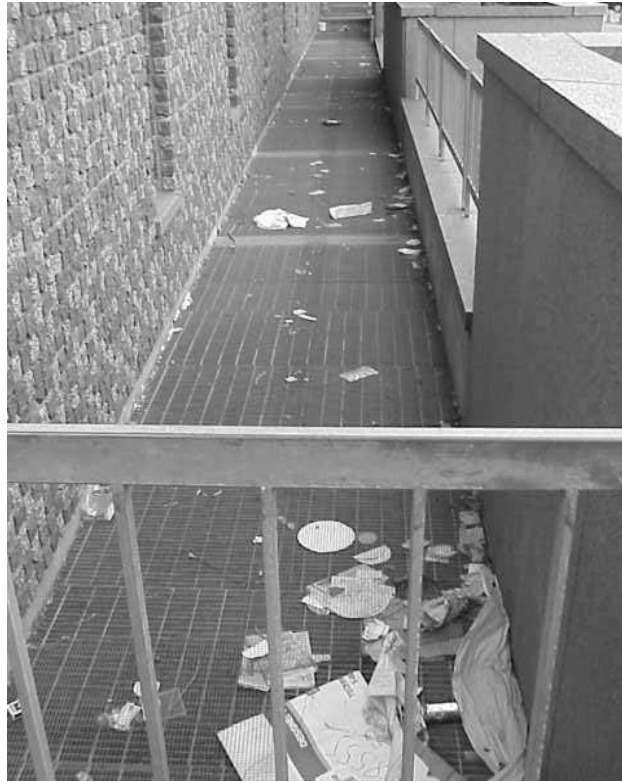
Picture 16

**Accumulation of Materials On Top Of Fresh Air Intake Vent for the Low-Rise
Section In the West Wall of the MCCT**

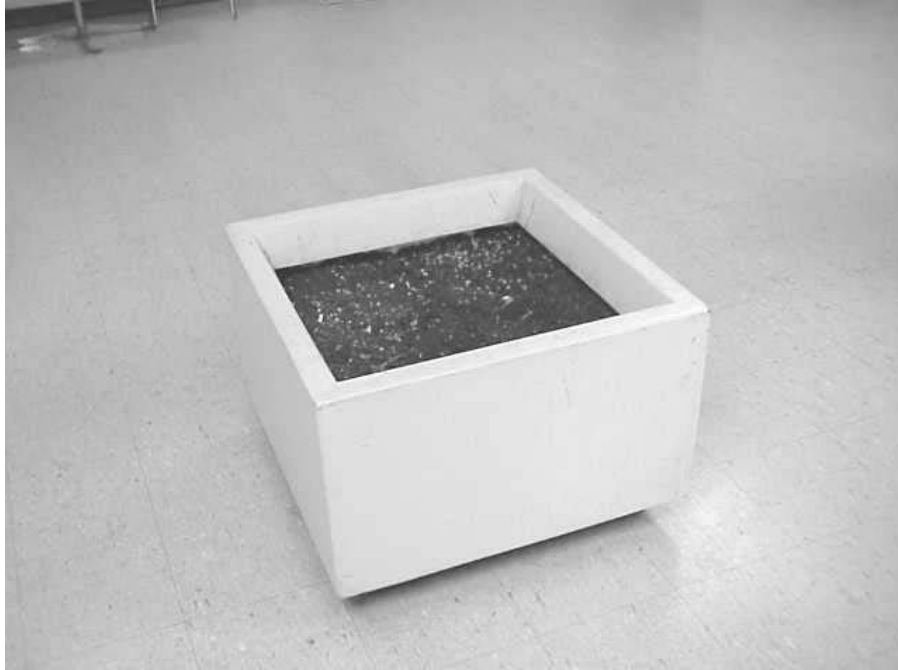
Picture 17

Planters Filled With Dirt in the Cafeteria

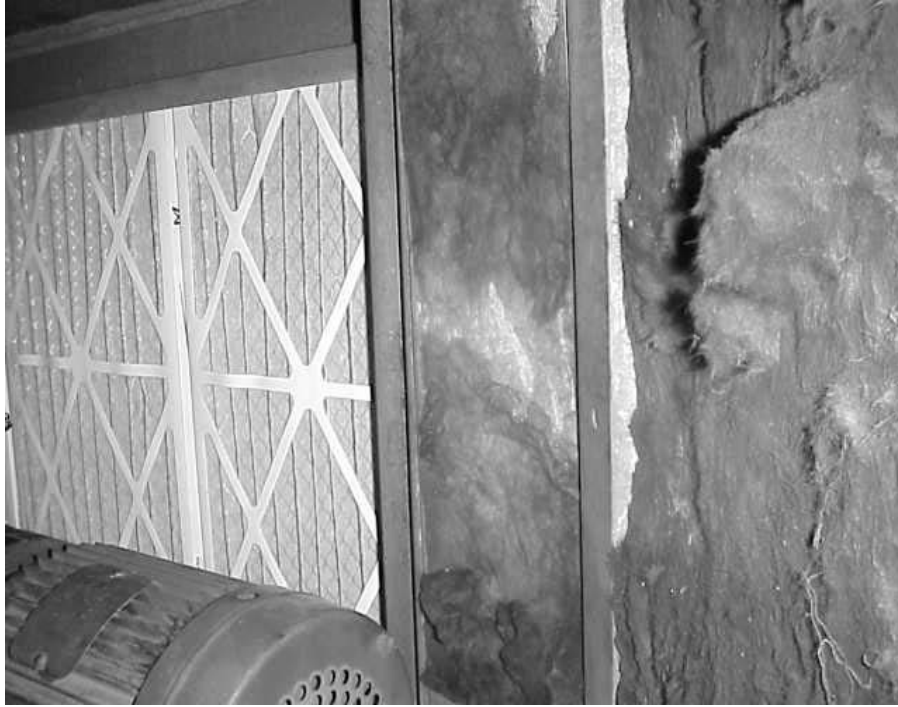
Picture 18

Fiberglass insulation inside many AHUs was abraded, torn or otherwise damaged (see Pictures 18 and 19). The condition of damaged fiberglass insulation inside AHUs coupled with the air movement provides the opportunity for airborne particulates to penetrate into occupied areas. Aerosolized dust, particulates and fiberglass can provide a source of eye, skin and respiratory irritation to certain individuals. In addition, these materials can accumulate on flat surfaces (e.g. desktops, shelving, carpets, etc.) below these areas and subsequently be re-aerosolized causing further irritation.

Damaged Fiberglass Insulation That Is Representative of Condition of Insulation Inside Of MCCT Tower AHUs

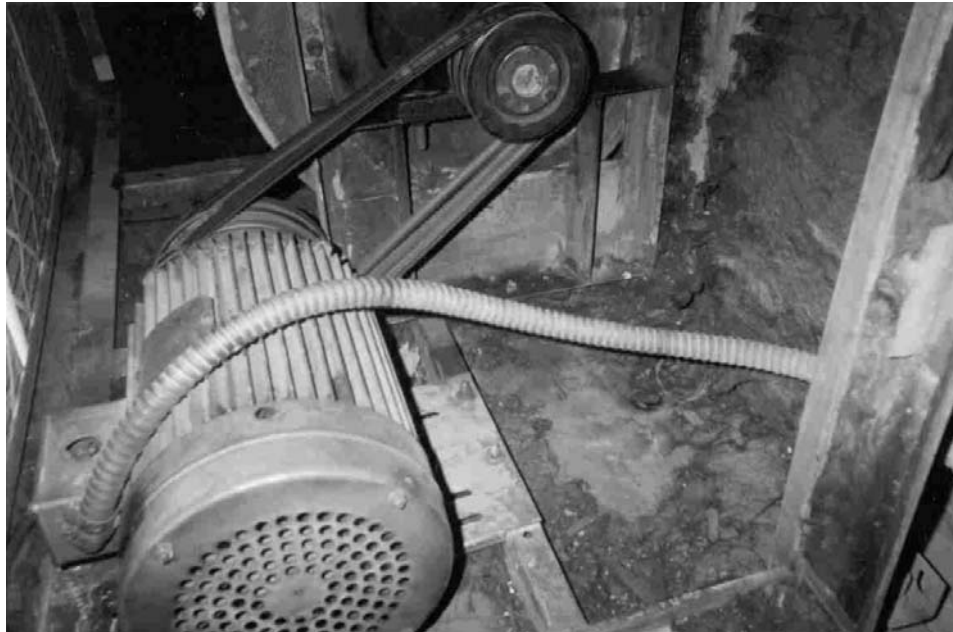
Picture 19

Damaged Fiberglass Insulation Inside AHU Servicing the MCSO
